# QueensWay

# **Existing Structural Conditions Report**

January 29, 2014

Weidlinger Associates, Inc.

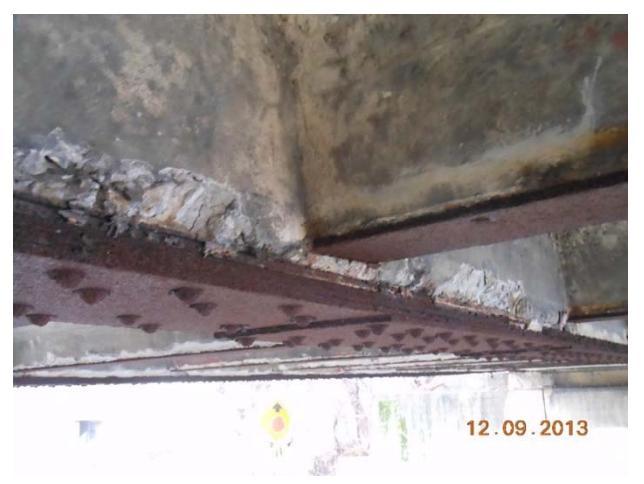
**Deck.** Along the underdeck, at the interface edges between exposed steel girders and floorbeams with the concrete deck, the edge of concrete is typically broken and spalled. This is a result of past corrosion of steel at the interface and its rust expansion on neighboring thin portions of concrete, resulting in concrete breaking off. This can be seen in Photos 1 and 2. Similarly, there are numerous isolated locations where the steel bar reinforcement inside the deck and beam

**Photo 1** - Typical concrete spalling along edge interface between steel and concrete (photo from Fleet St.)

Due to these conditions, we recommend that the underside of the concrete decks be thoroughly sounded and cleaned to remove any delaminated concrete pieces at these bridges. We also recommend that all exposed steel be sandblasted and painted, including exposed steel reinforcement.

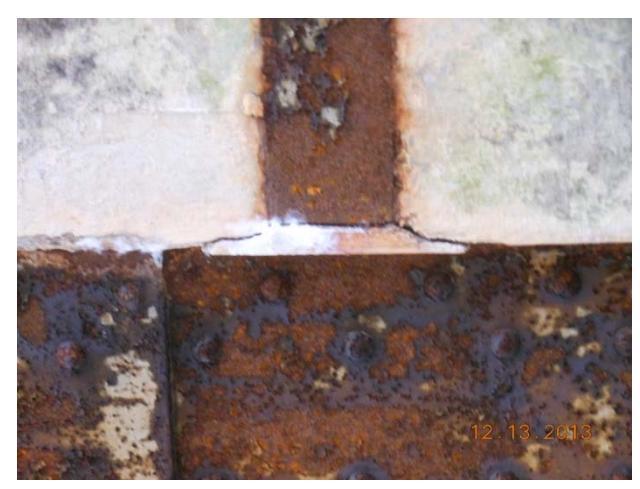
**Photo 2** - Concrete spalling along edge interface between steel and concrete (photo from Park Lane South, looking up at underdeck)

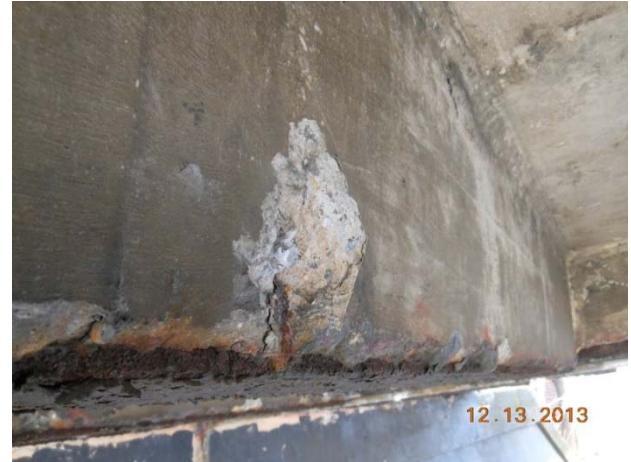
**Photo 3** - Concrete spalling along beam's concrete encasement (photo from Jamaica Ave.)

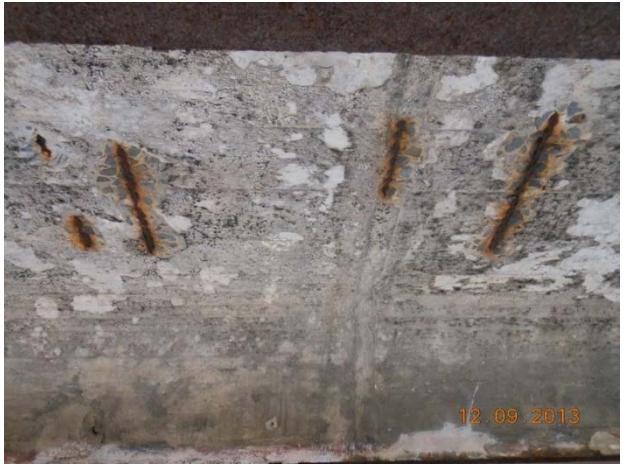
encasement is exposed; again, this is a result of past corrosion of the steel bars, which expand and force the thin cover of concrete over the bars to pop out, resulting in concrete spalls. This is shown in Photos 3 and 4. These defects are minor in significance; however, they cause small pieces of concrete debris to detach and possibly fall onto traffic below, representing potential safety hazards. As there was no observed signs of active or prolonged water infiltration at these defects. this corrosion is not believed to be caused by water leakage from above the deck, and instead it is due to exposure to moisture from below the deck. Our assessment is that the decks at these bridges can be maintained for future use.

**Photo 4** – Underside of deck. Spalled concrete with exposed, lightly rusted, rebar (photo from Fleet St.)

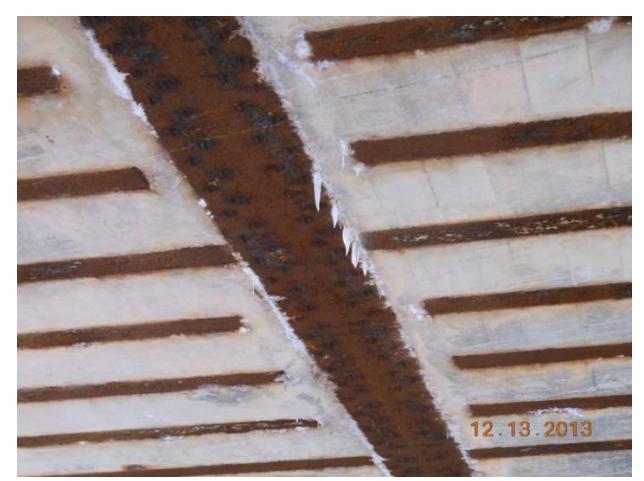
At Park Lane South and the 91<sup>st</sup> Ave. bridge, there are some light efflorescence formations along the edges of the bottom flanges of the thru-girders with minor active leakage, as evidenced by the formation of icicles noted during the inspection. These are symptoms of water infiltration into the deck from above. See Photo 5. These conditions, however, are isolated and not considered sufficiently significant and prevalent to warrant a corrective repair, which would require removal of the ballast, brick/concrete protection layers, and waterproofing layers above the deck to properly perform the repair.

**Photo 5** – Icicle formation along edge of thru-girder, with areas of white efflorescence, indicating some water leakage from above. (photo from Park Lane South)

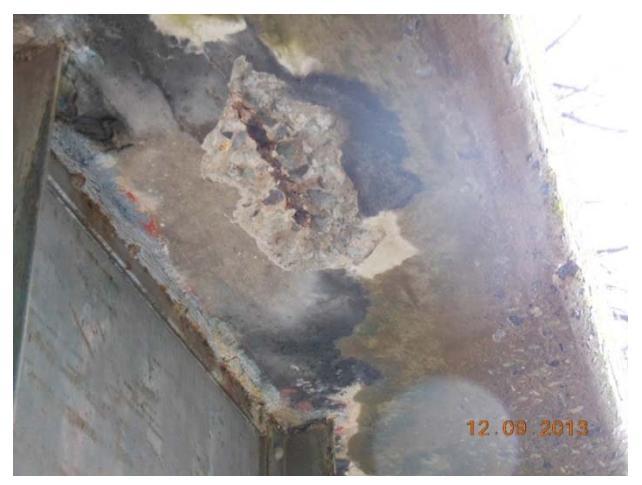
**Deck.** At Yellowstone Blvd., the underside of deck outside of the fascia girders exhibited more delaminated, hollow-sounding, and spalled concrete with exposed rebars. These appears to be the result of water exposure from the fascia, and the delaminated, hollow-sounding, and spalled concrete will need to be repaired. See Photos 6 and 7.

**Photo 6** – Yellowstone Blvd. bridge, underside of deck along fascia. Typical discolored, delaminated, hollowsounding, and spalled concrete, with exposed rebar. Typical along fascia.

Due to the above-described conditions, we recommend that the underside of the concrete decks be thoroughly sounded and cleaned to remove any delaminated concrete pieces at these bridges. We also recommend that all exposed steel be sandblasted and painted, including exposed steel reinforcement. **Steel Substructure.** The base of steel columns at Yellowstone Blvd. exhibit corrosion and deterioration at their interface with concrete base encasements, which are broken due to the expansion of the column steel's rust. See Photos 11 and 12. The corrosion results in loss of structural section and capacity for the steel column, though it is not at a level that causes structural concern. These defects should, however, be addressed so that further corrosion and loss of section is prevented. *Thus for Yellowstone Blvd., we recommend that all the column base concrete encasements be replaced, and the columns with significant section loss be reinforced.* The steel substructure at Metropolitan Ave. and Atlantic Ave. were generally observed to be in good condition.

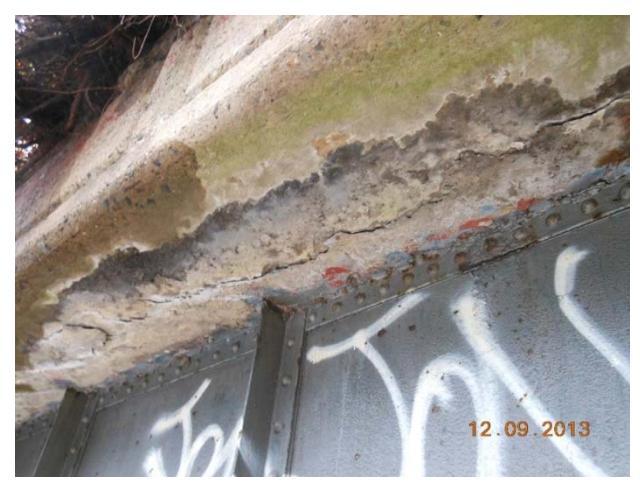
**Photo 7** – Yellowstone Blvd. bridge, underside of deck along fascia. Typical discolored, delaminated, hollow-sounding concrete. Typical along fascia.

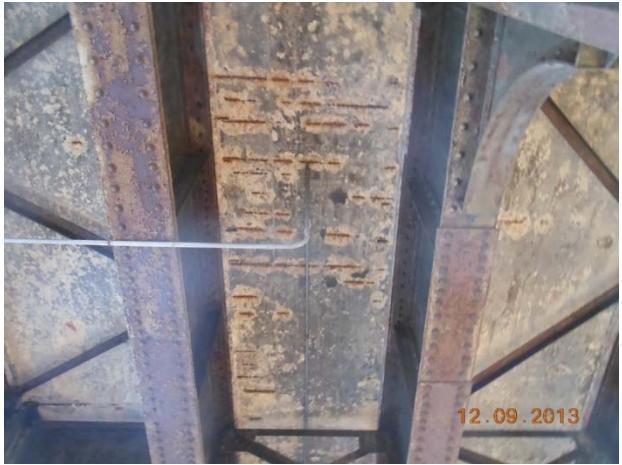
The underside of deck between fascia girders at Yellowstone Blvd., the entire underside of deck at Metropolitan Ave., and the underside of deck and platforms at Atlantic Ave. exhibit numerous areas where the steel bar reinforcement inside the deck is exposed; this is a result of past corrosion of the steel bars in combination with thin concrete cover over the bars or joint leakage, which results in concrete spalling off. This is shown in Photos 8-10.

**Photo 8** – Yellowstone Blvd. bridge, underside of deck. Spalled concrete, with exposed rebar, due to thin cover concrete.

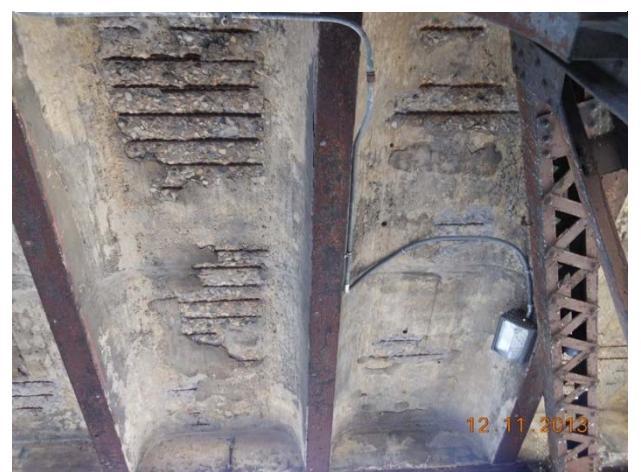
**Photo 9** – Metropolitan Ave. bridge, underside of deck. Spalled concrete, with exposed rebar, due to thin cover concrete.

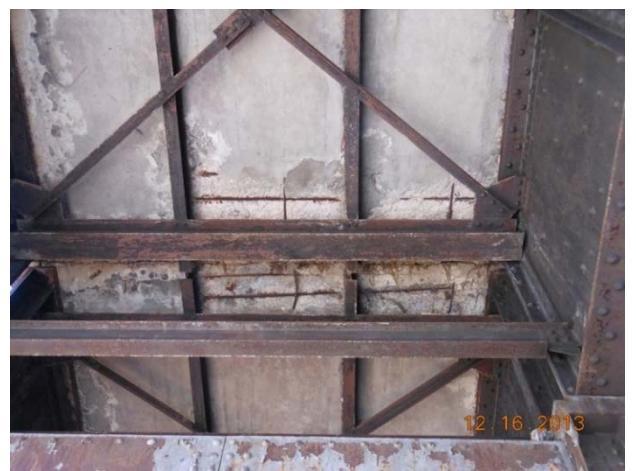
**Photo 10** – Atlantic Ave. bridge, underside of platform deck. Spalled concrete, with exposed rebar, due to joint leakage.

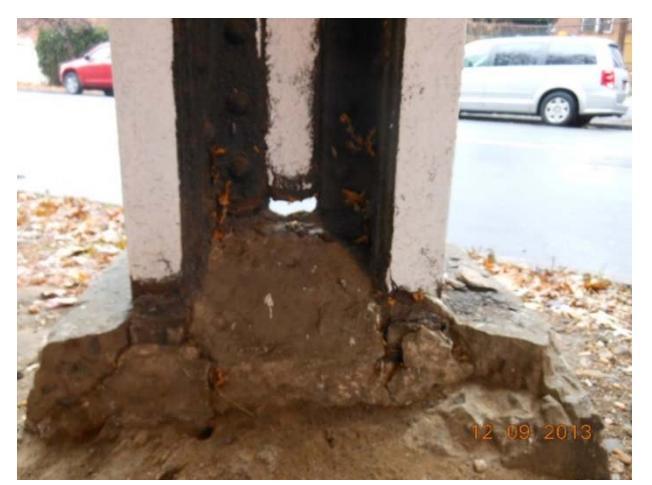
**Photo 11** – Yellowstone Blvd. bridge, base of steel column is corroded, with base concrete encasement broken.

**Steel Substructure.** At Yellowstone Blvd., we recommend that all the column base concrete encasements be replaced, and the columns with section loss be reinforced. For all three bridges, and blast cleaning and painting of the steel substructure elements is recommended.

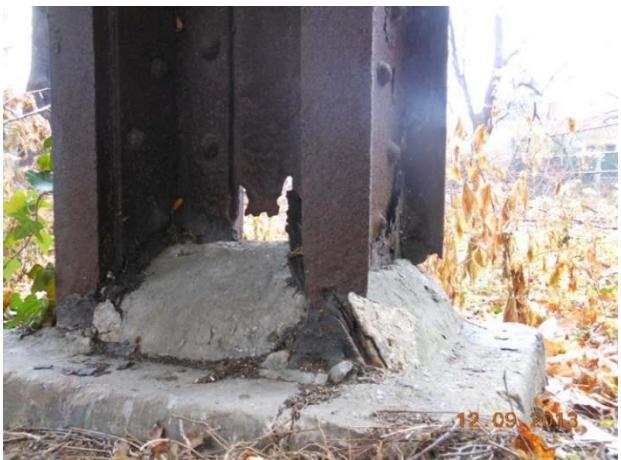
**Photo 12**– Yellowstone Blvd. bridge, base of steel column corrosion.

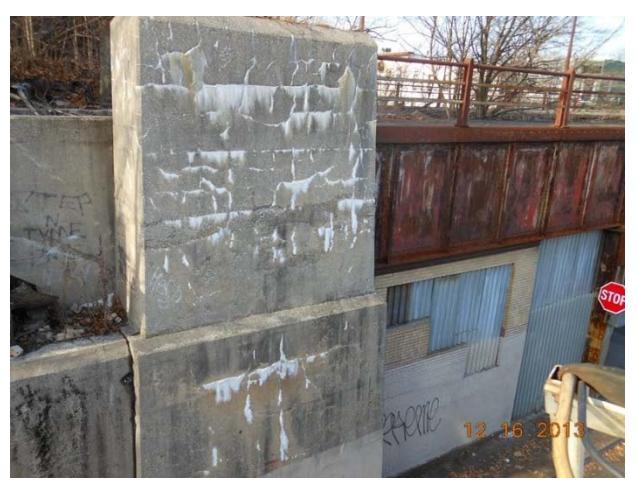
**Photo 13** – Concrete pylon above Atlantic Ave. bridge's south abutment, east wingwall, with cracks and efflorescence.

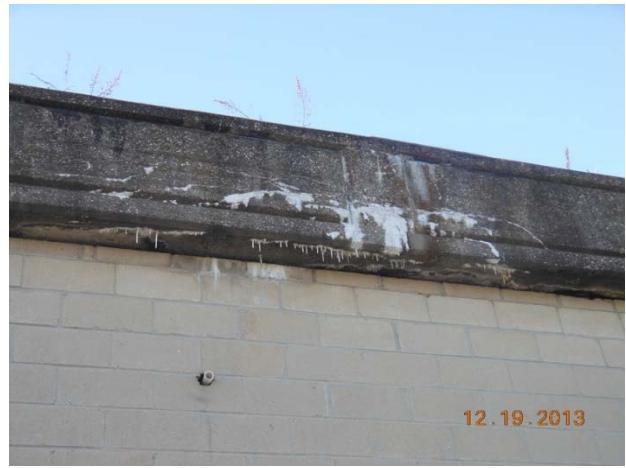
**Deck Fascia.** This fascia concrete is in poor condition for approximately 30% of the viaduct's fascia length, with the remainder of the fascia length in better, but only fair condition. If left alone without repair or addressing, this fascia will continue to weather and deteriorate, and the concrete will continue to spall off. See Photos 14 thru 21.

**Photo 14 -** Typical deteriorated fascia concrete along viaduct structure with cracking and efflorescence.

Due to the advanced deterioration of the fascia along 30% of the viaduct's fascia's length, we would recommend replacing and reconstructing this length of fascia, with the remaining 70% to receive rehabilitation through cleaning and sealing to protect the concrete surface and mitigate against future water exposure.

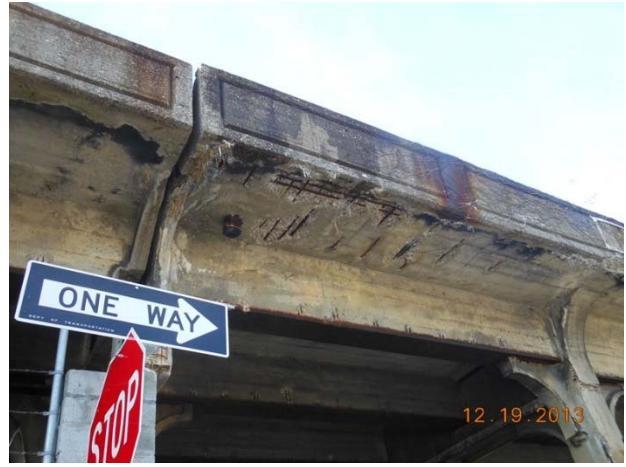
**Photo 15** - Typical spalling with exposed rebars along underside of fascia at viaduct structure.

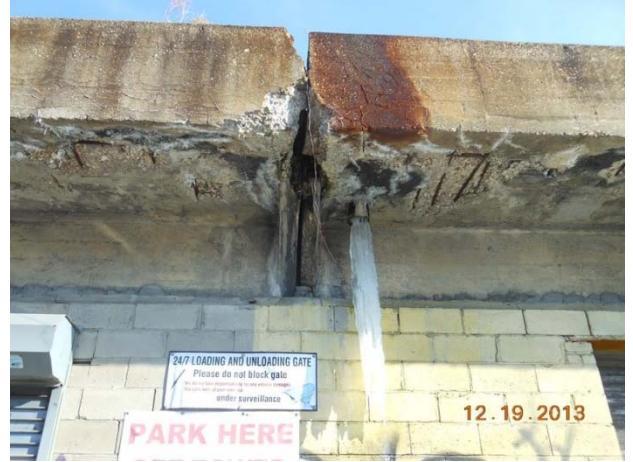
**Photo 16** - Typical heavy deterioration and spalling along fascia concrete at transverse joint locations along viaduct structure.

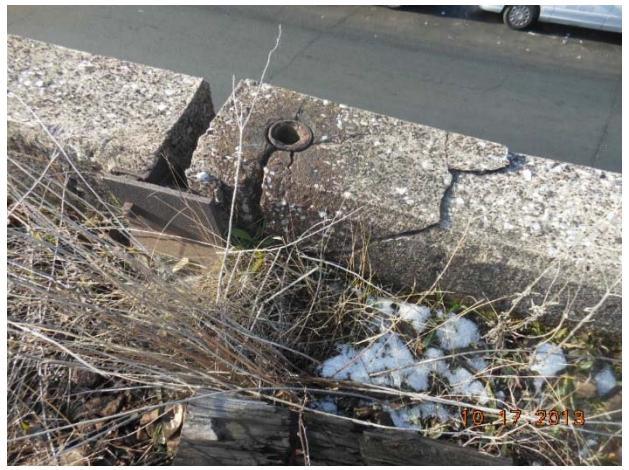
**Photo 17** - Typical deterioration and broken fascia fascia concrete at transverse joint locations, viewed from above viaduct structure.

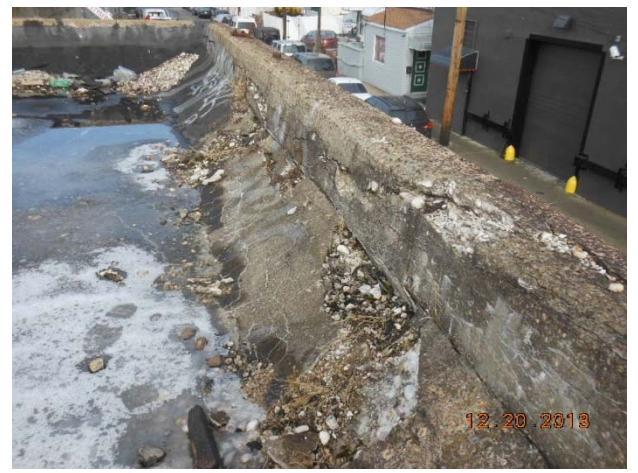
**Photo 18** – View of cracking and spalling of top of fascia along viaduct structure. Note there is no ballast or fill at this portion of the structure.

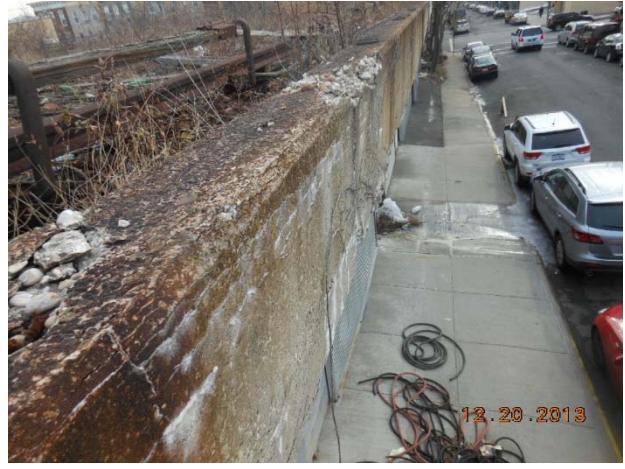
**Photo 19** – View of cracking and efflorescence along top of fascia of viaduct structure.

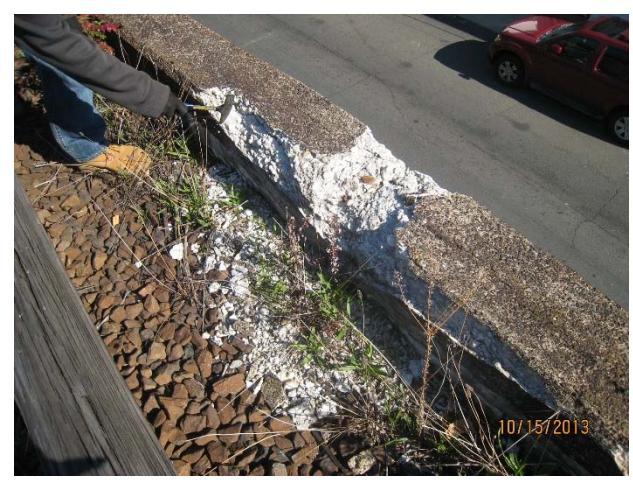
**Photo 20** – Spalling along top of fascia of viaduct structure.

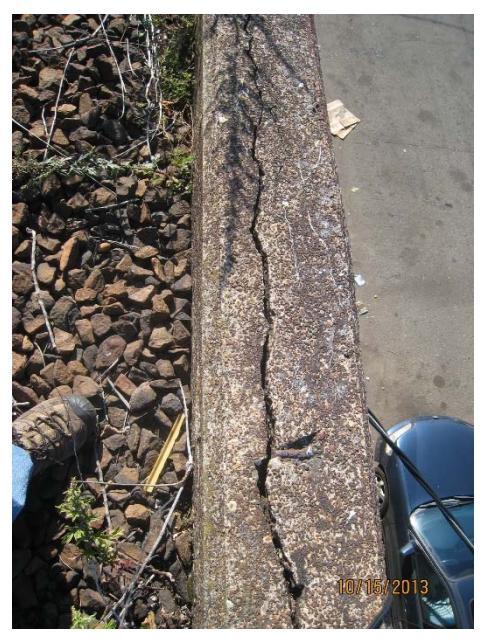
**Photo 21** – Large crack along top of fascia of viaduct structure.

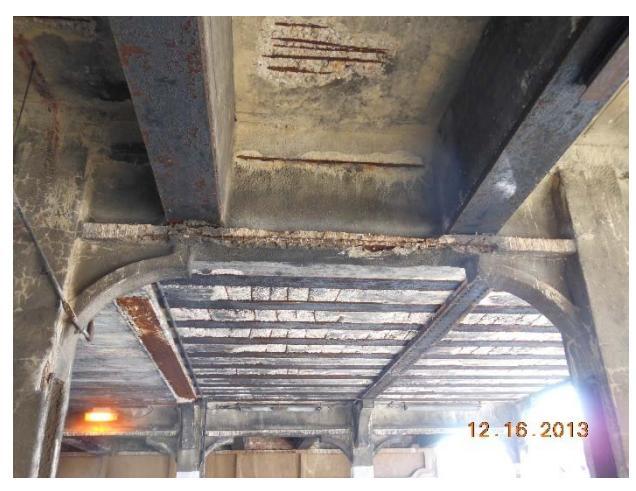
The underside of deck at bridges crossing over 97 Ave., 101 Ave., 103 Ave., Liberty Ave., and Rockaway Blvd. are all similar to each other in that they typically consist of three-span structures with only the longer middle span comprised of thru-girders with transverse floorbeam framing. Their underside of deck conditions are also similar to the conditions observed at Yellowstone. Blvd, Metropolitan Ave., and Atlantic Ave. in that while their steel framing appeared to be generally good, the underside of the deck exhibits spalling with exposed reinforcement bars as a common condition throughout the spans. Also, similar to what was observed at all other bridges, the interface edges between exposed steel with the concrete deck exhibited concrete edges that are broken and spalled. See Photos 22 to 26.

**Photo 22 –** Spalling with exposed rebar in spans at 97 Ave.

Deck Underside at bridges crossing over 97 Ave., 101 Ave., 103 Ave., Liberty Ave., and Rockaway Blvd. We recommend that the underside of the concrete decks be thoroughly sounded and cleaned to remove any delaminated concrete pieces at these bridges. We also recommend that all exposed steel be sandblasted and painted, including exposed steel reinforcement.

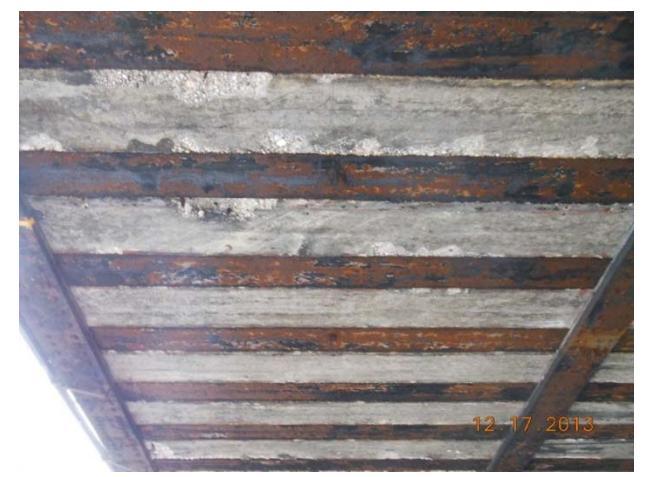
**Photo 23** – Spalling of concrete edges along exposed steel at 101 Ave.

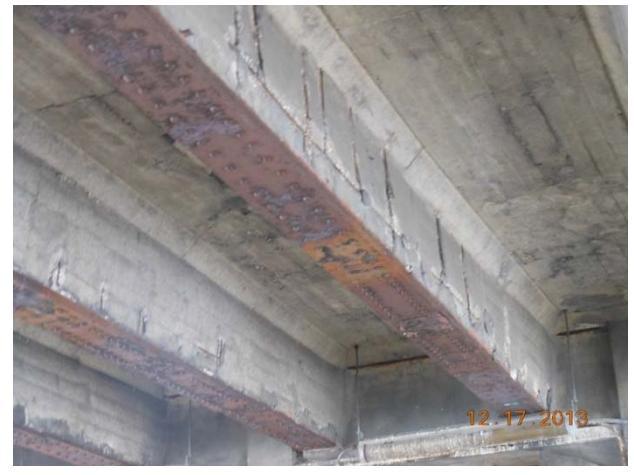
**Photo 24** – Spalling of beam encasement concrete due to thin cover over encasement rebar at 103 Ave.

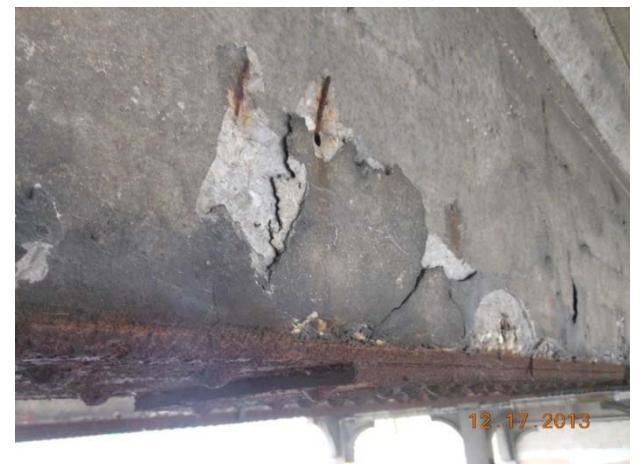
**Photo 25** – Delaminated and spalling of beam encasement concrete due to thin cover over encasement rebar at 103 Ave.

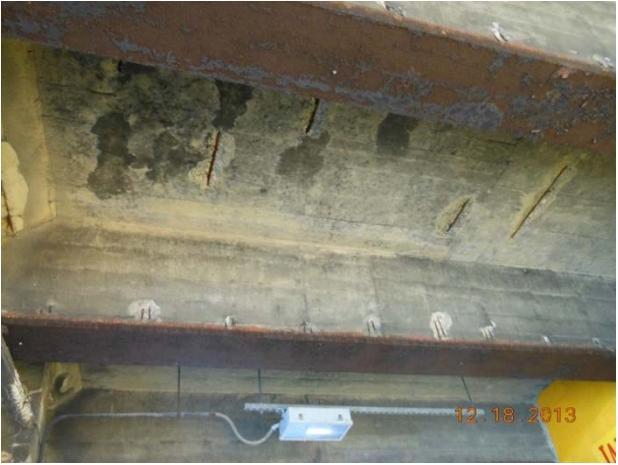
**Photo 26** – Spalling underdside of deck and of beam encasement concrete due to thin cover at Liberty Ave.

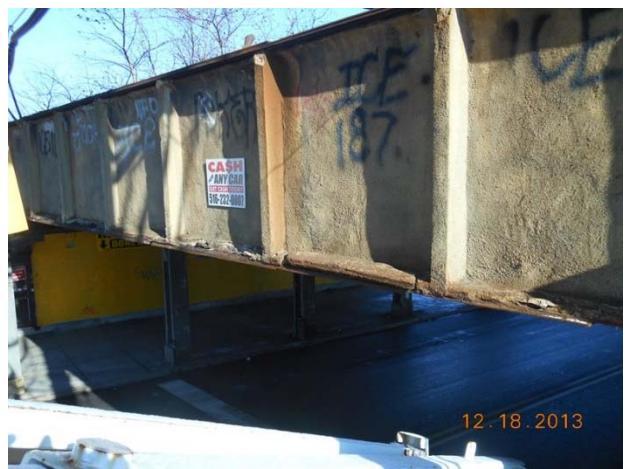
At the fascia beams over the longer middle spans at the 97 Ave., 101 Ave., 103 Ave., Liberty Ave., and Rockaway Blvd. bridges, the gunite is typically in fair condition, and still bonded to the steel girder it is covering. The worst condition was observed at Liberty Ave., where large pieces of the gunite were observed to be delaminated, and was easily removed by the inspection team. This gunite can easily fall onto the vehicular traffic below. See Photo 27.

**Photo 27** – Delaminated and broken gunite along bottom flange of fascia girder at Liberty Ave.

**Gunite on Steel Fascias and Subtructural Steel.** We recommend that gunite be removed along all locations that it exists. This will expose the steel that it currently covers, which will need to be sandblasted and painted.

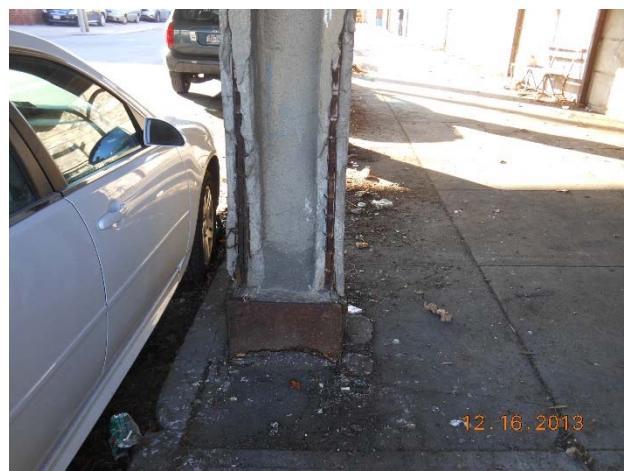
The pier columns and capbeams at the 97 Ave., 101 Ave., 103 Ave., Liberty Ave., and Rockaway Blvd. bridge crossings were all observed to be in poor condition, with many locations of broken, spalled, and missing gunite. At these locations, the mesh and underlying steel structure is exposed. See Photos 28 to 30 for typical conditions.

**Photo 28** – Broken and missing gunite along bottom of pier column at 97 Ave.

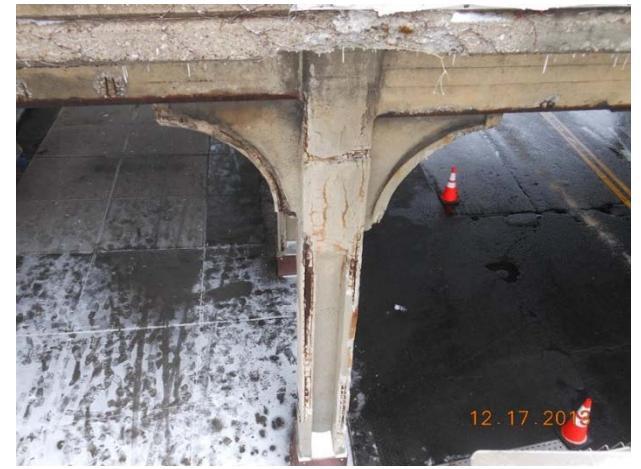
**Photo 29** – Broken and missing gunite along of pier column at 103 Ave.

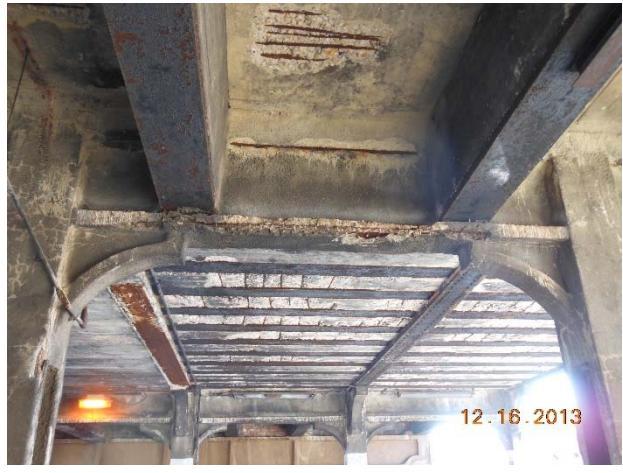
**Photo 30 –** Broken gunite with exposed mesh along pier cap beam at 97 Ave.

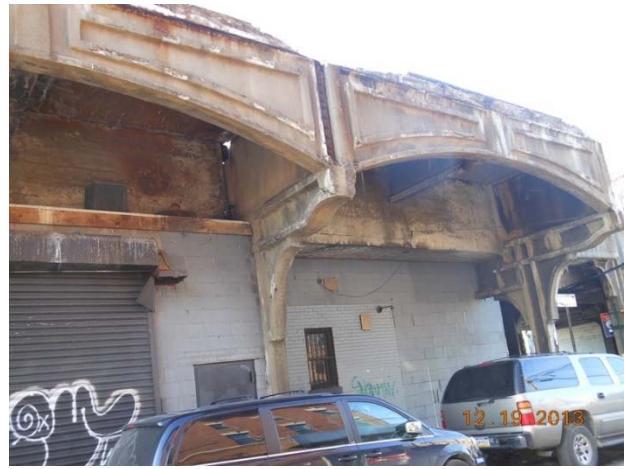
Between 101 Ave. and 103 Ave., the former station platform slabs are supported on pier cap beams and longitudinal arched beams along the fascia of the platforms. These supporting members are also encased in gunite, and in poor condition. See Photos 31 and 32.

**Photo 31** – Gunite-covered fascia arch beams supporting the platform slabs between 101 Ave and 103 Ave.

The gunite in all the locations described above will continue to deteriorate and delaminate over time, resulting in future falling debris hazards for passing traffic below. We recommend that this gunite be removed in all these locations, which is a significant quantity of work. This will expose the steel that the gunite currently covers, which will need to be sandblasted and painted.

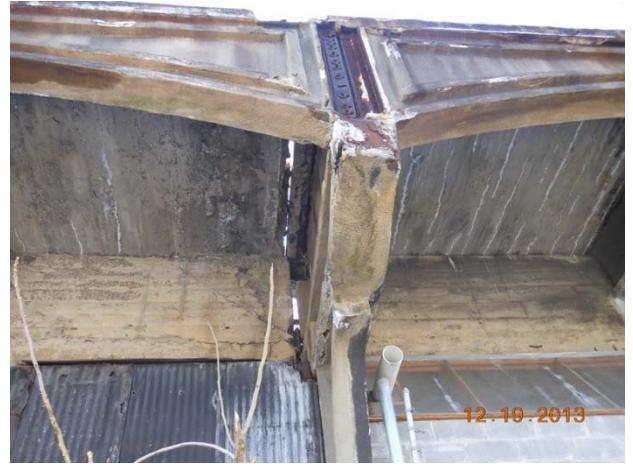
**Photo 32** – Gunite-covered fascia arch beams at pier expansion joint, between 101 Ave and 103 Ave. Note cracking along underside of platform slabs.

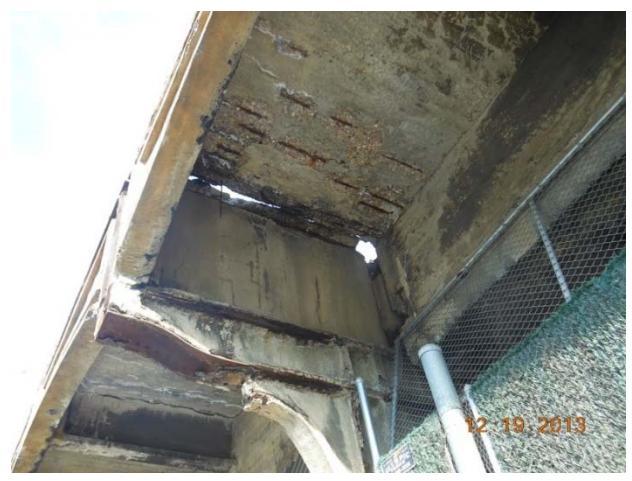
**Platforms Slabs between 101 Ave. and 103 Ave.** In contrast to the former station platform slabs at Atlantic Avenue, which were inspected to be in good condition, the platforms slabs between 101 Ave. and 103 Ave. are in very poor condition. Along the entire RBB, these members are the only ones whose structural condition is suspect and cannot be relied on. The slabs exhibit prevalent cracking and efflorescence throughout its underside, many locations where holes have developed, revealing the slab reinforcement. *We recommend that these slabs cannot be retained and should be removed.* See Photos 32 to 34.

**Photo 33** – Holes, spalling, and cracking along the underside of platforms slabs between 101 Ave and 103 Ave.

Platforms Slabs between 101 Ave. and 103 Ave. We recommend that the platforms slabs be removed.

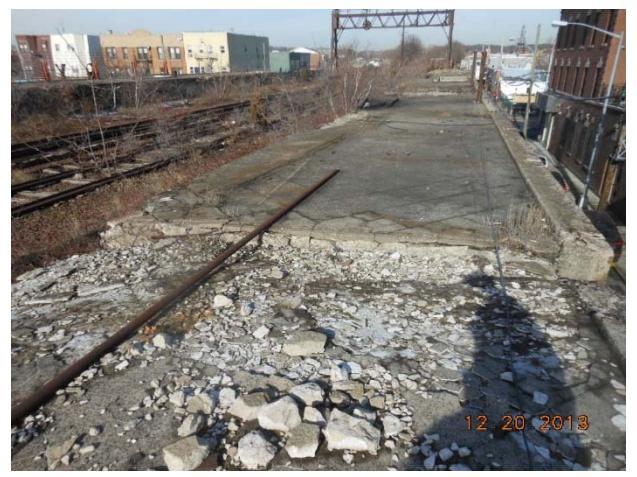
**Photo 34** – View along top of platforms slabs between 101 Ave and 103 Ave.

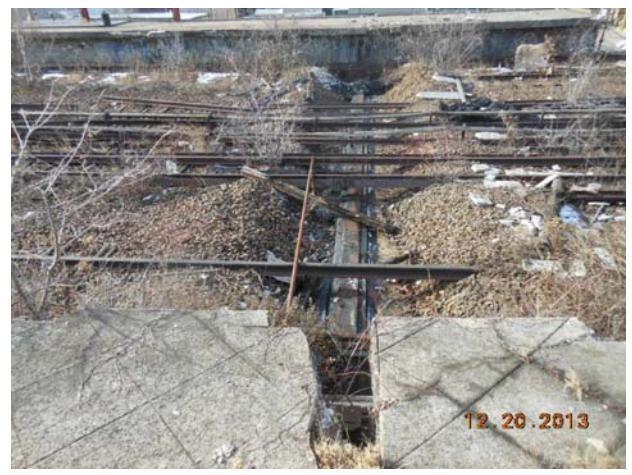
**Expansion Joints.** There are 22 transverse expansion joints located within the 111-span viaduct structure, typically located at every fifth pier. While walking along the top of the viaduct, we observed several locations where the sliding steel plate expansion joint had been uncovered and exposed, with surrounding ballast and fill excavated, and appear to have been sealed with roofing tar and sealer. This suggests that someone in the recent past performed this work to prevent leakage of water through the joint and into the structure below. Since there was no uniformity in the work done at several joints, we believe that the occupants of each property below the joint took liberty to perform this work. At the one location below the deck where we were able to access

**Photo 35** – View along top of expansion joint; note ballast has been excavated from joint.

an expansion joint, we did observe water leakage through the joint. *Thus, we recommend that rehabilitation all expansion joints along the viaduct be performed to mitigate against water leakage into the structure below.* See Photos 35 to 36.

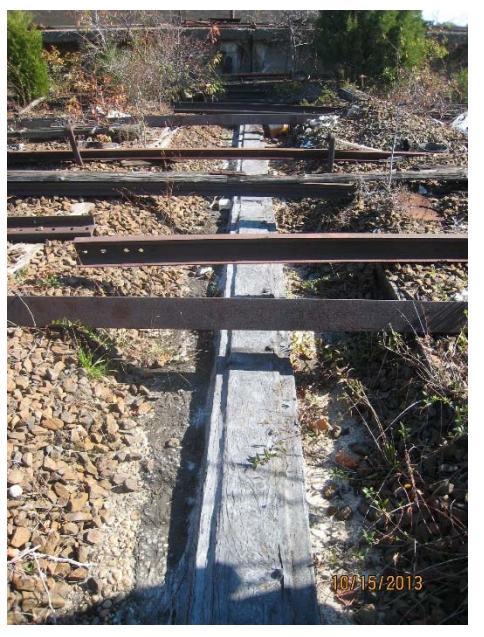
**Photo 36** – View along top of expansion joint; note ballast has been excavated from joint.

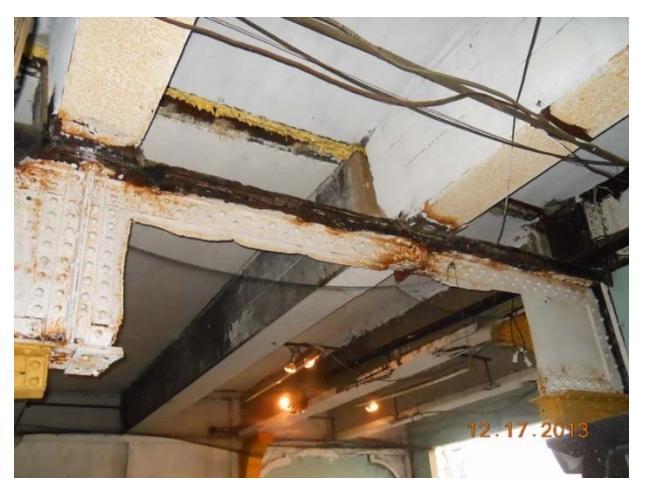
**Miscellaneous Conditions.** At Pier 81, we observed the steel pier cap beam to be inappropriately cut for <sup>3</sup>/<sub>4</sub> of its depth. See Photo 37. It appears that this was done to create vertical clearance underneath the structure for the occupants below. Since there is no live load on the structure, there is sufficient capacity to support existing dead loads, as there is no observed structural distress. *However, we recommend that this cap beam must be repaired.* With limited access to the underside of the structure due to closed commercial properties, we observed no other similar conditions, and assume no other locations such as this exist along the viaduct.

**Photo 37** – Pier 81 cap beam is inappropriately cut. Note deck expansion joint above this cap beam.

**Miscellaneous Conditions.** We recommend that the cut cap beam at Pier 81 be repaired.

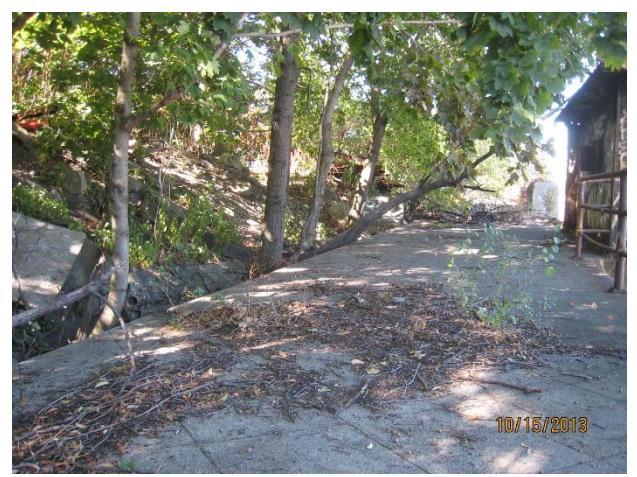
**Photo 38** – At Atlantic Ave. bridge, former station east platform at south end. Note debris piled up above the level of the platform slab (at left side of photo).

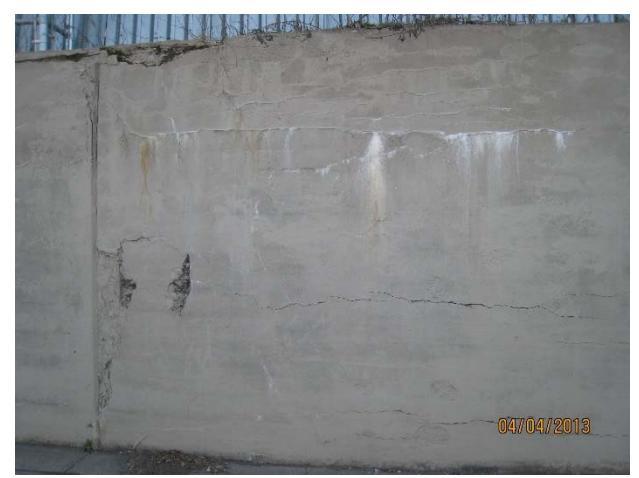
At the varying height concrete retaining wall between Atlantic Ave. and 97<sup>th</sup> Ave. along the east ROW, the wall is in fair condition and exhibits some defects that indicate future problems may develop. This wall varies from 8' to 12' high along its length, and supports significant surcharge loading from the sloped embankment of the RBB behind it, especially at the north end near Atlantic Ave., where additional fill and debris were previously deposited onto the railway, and reaches several feet above the elevation of the adjacent platform slabs. See Photo 38. This retaining wall shows horizontal cracking along for approximately 50% of its 875' length, and a couple of locations where water is seeping through the cracks, causing localized spalling in the wall. See Photos 39 to 41. No weepholes were observed along the length of the wall, suggesting that hydrostatic pressure behind the wall will cause additional loading onto the wall. The wall was generally observed to be vertically plumb. *We recommend that continue monitoring of the wall be done, and future rehabilitation of this wall may need to be considered*.

**Photo 40** – Retaining wall along east side slope of railway between Atlantic Ave. and 97 Ave. Typical horizontal cracking, efflorescence, and spalling.

At the varying height concrete retaining wall between Atlantic Ave. and 97<sup>th</sup> Ave. along the east ROW, we recommend that continue monitoring of the wall be done.

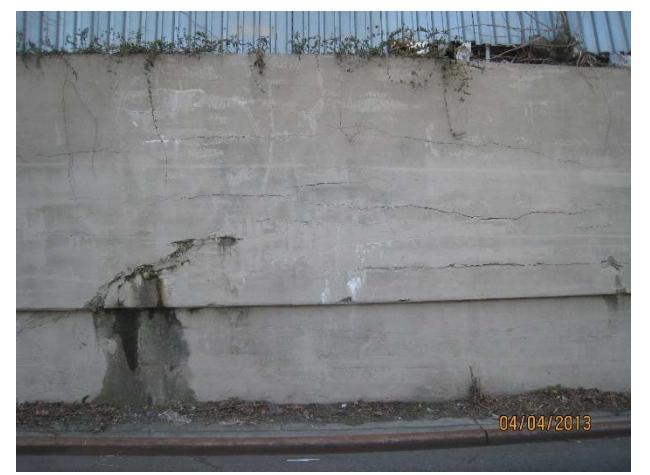
**Photo 41** – Retaining wall along east side slope of railway between Atlantic Ave. and 97 Ave. Isolated location of spalling with water leakage from behind wall.

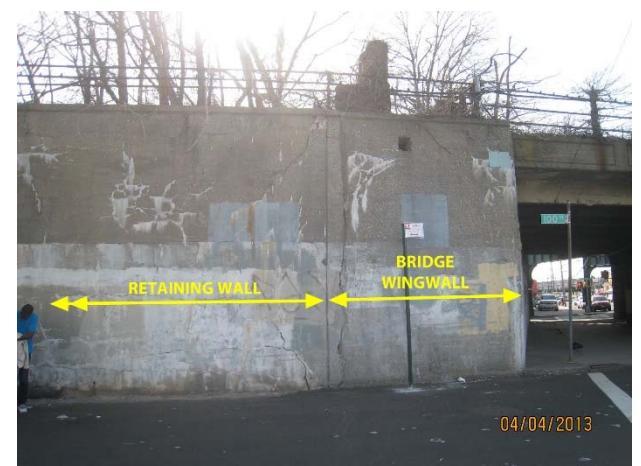
At the south end of the project limits, at the Rockaway Blvd. bridge, the south abutment of the bridge and its adjacent concrete wingwalls and retaining walls also support the elevated rail line. We assume the limits of this project ends with the wingwalls that are adjacent to the bridge's south abutment; these wingwalls extend 15' beyond the south abutment, after which retaining walls continue south. The abutment wingwalls are in fair condition; however, the retaining walls continuing south are in poor condition, especially along the east side on 100 St., where prevalent horizontal cracking with efflorescence exists throughout its 20' height. See Photo 42.

**Photo 42** – Limits of bridge wingwall and retaining wall along east side of railway just south of Rockaway Blvd.

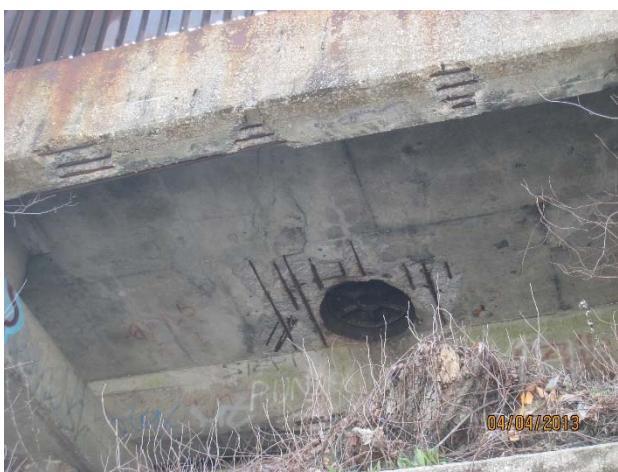
**Photo 43** – Underside of platform slab structure at former Atlantic Ave. station; typical spalling of reinforced concrete.

We recommend that this project determine if these platforms and their substructural components will be retained and used in the future. If so, then their rehabilitation should be included, which would consist of general concrete spall repair.
