# QueensWay

# **Existing Structural Conditions Report**

January 29, 2014

Weidlinger Associates, Inc.

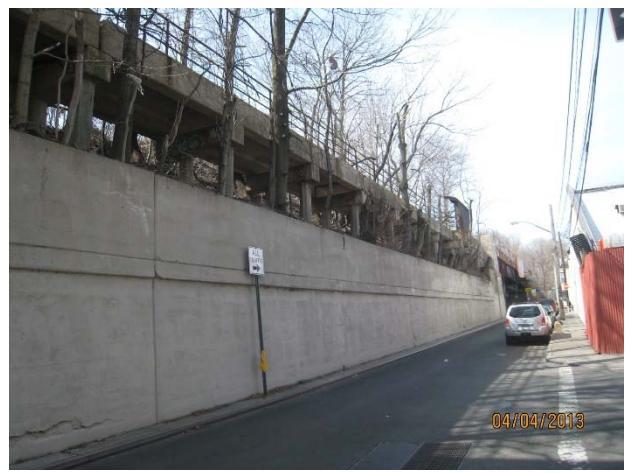
At the varying height concrete retaining wall between Atlantic Ave. and 97<sup>th</sup> Ave. along the east ROW, the wall is in fair condition and exhibits some defects that indicate future problems may develop. This wall varies from 8' to 12' high along its length, and supports significant surcharge loading from the sloped embankment of the RBB behind it, especially at the north end near Atlantic Ave., where additional fill and debris were previously deposited onto the railway, and reaches several feet above the elevation of the adjacent platform slabs. See Photo 38. This retaining wall shows horizontal cracking along for approximately 50% of its 875' length, and a couple of locations where water is seeping through the cracks, causing localized spalling in the wall. See Photos 39 to 41. No weepholes were observed along the length of the wall, suggesting that hydrostatic pressure behind the wall will cause additional loading onto the wall. The wall was generally observed to be vertically plumb. *We recommend that continue monitoring of the wall be done, and future rehabilitation of this wall may need to be considered*.

**Photo 39** – Retaining wall along east side slope of railway between Atlantic Ave. and 97 Ave. Note former station platform structure above wall.

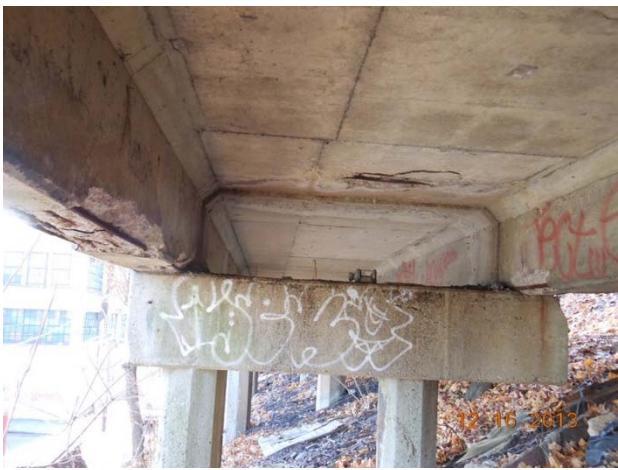
The former station at Atlantic Ave. consists of two concrete platforms which, away from the fivespan bridge, are supported by concrete piers founded into the earthen embankment below. The length of the platforms extend north and south to 93<sup>rd</sup> Ave and 94<sup>th</sup> Ave., respectively, and is approximately 600' long. Below on both the north and south ends of the bridge, the former streetlevel entrances and staircases connecting to the platforms above are currently fenced off, with the connection of the stairways to the platforms blocked off with concrete block walls. The platform slabs and supporting structure throughout this station were observed to be in fair condition, and can be retained. The platform reinforced concrete slab structure exhibits numerous locations of spalled concrete with exposed rebars, as does the substructural piers. See Photos 39, 43, and 44.

**Photo 43** – Underside of platform slab structure at former Atlantic Ave. station; typical spalling of reinforced concrete.

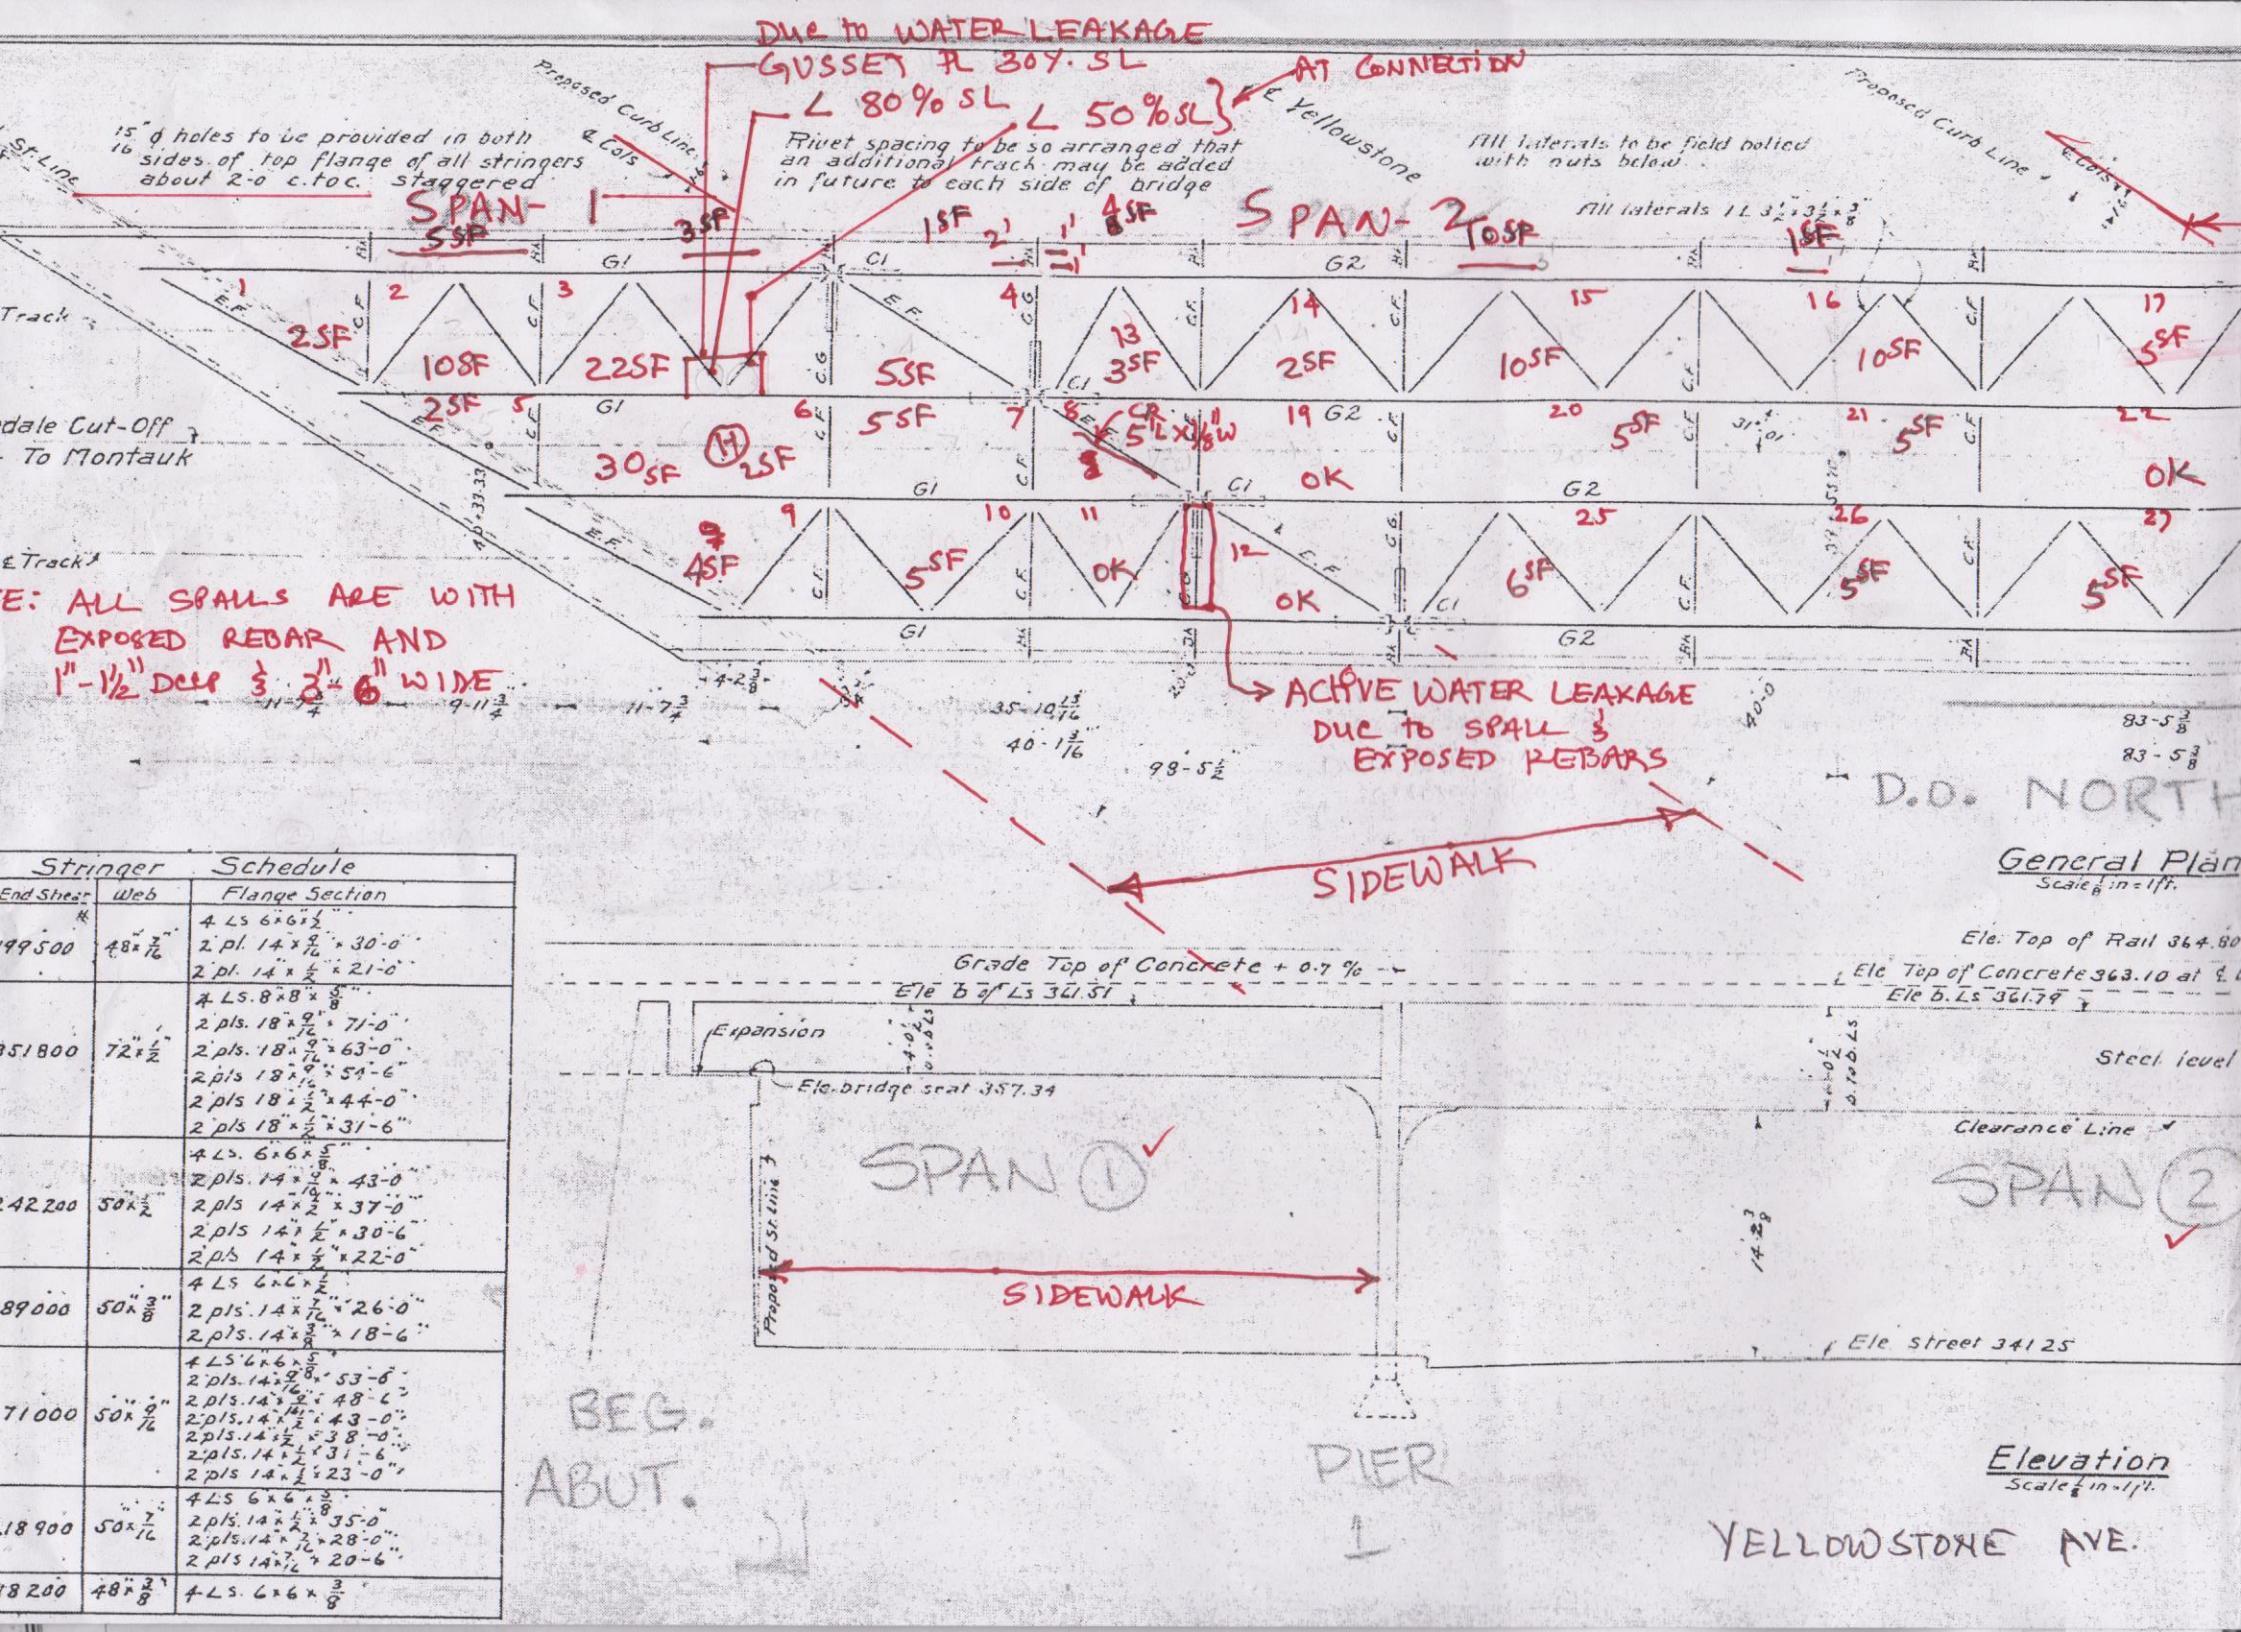
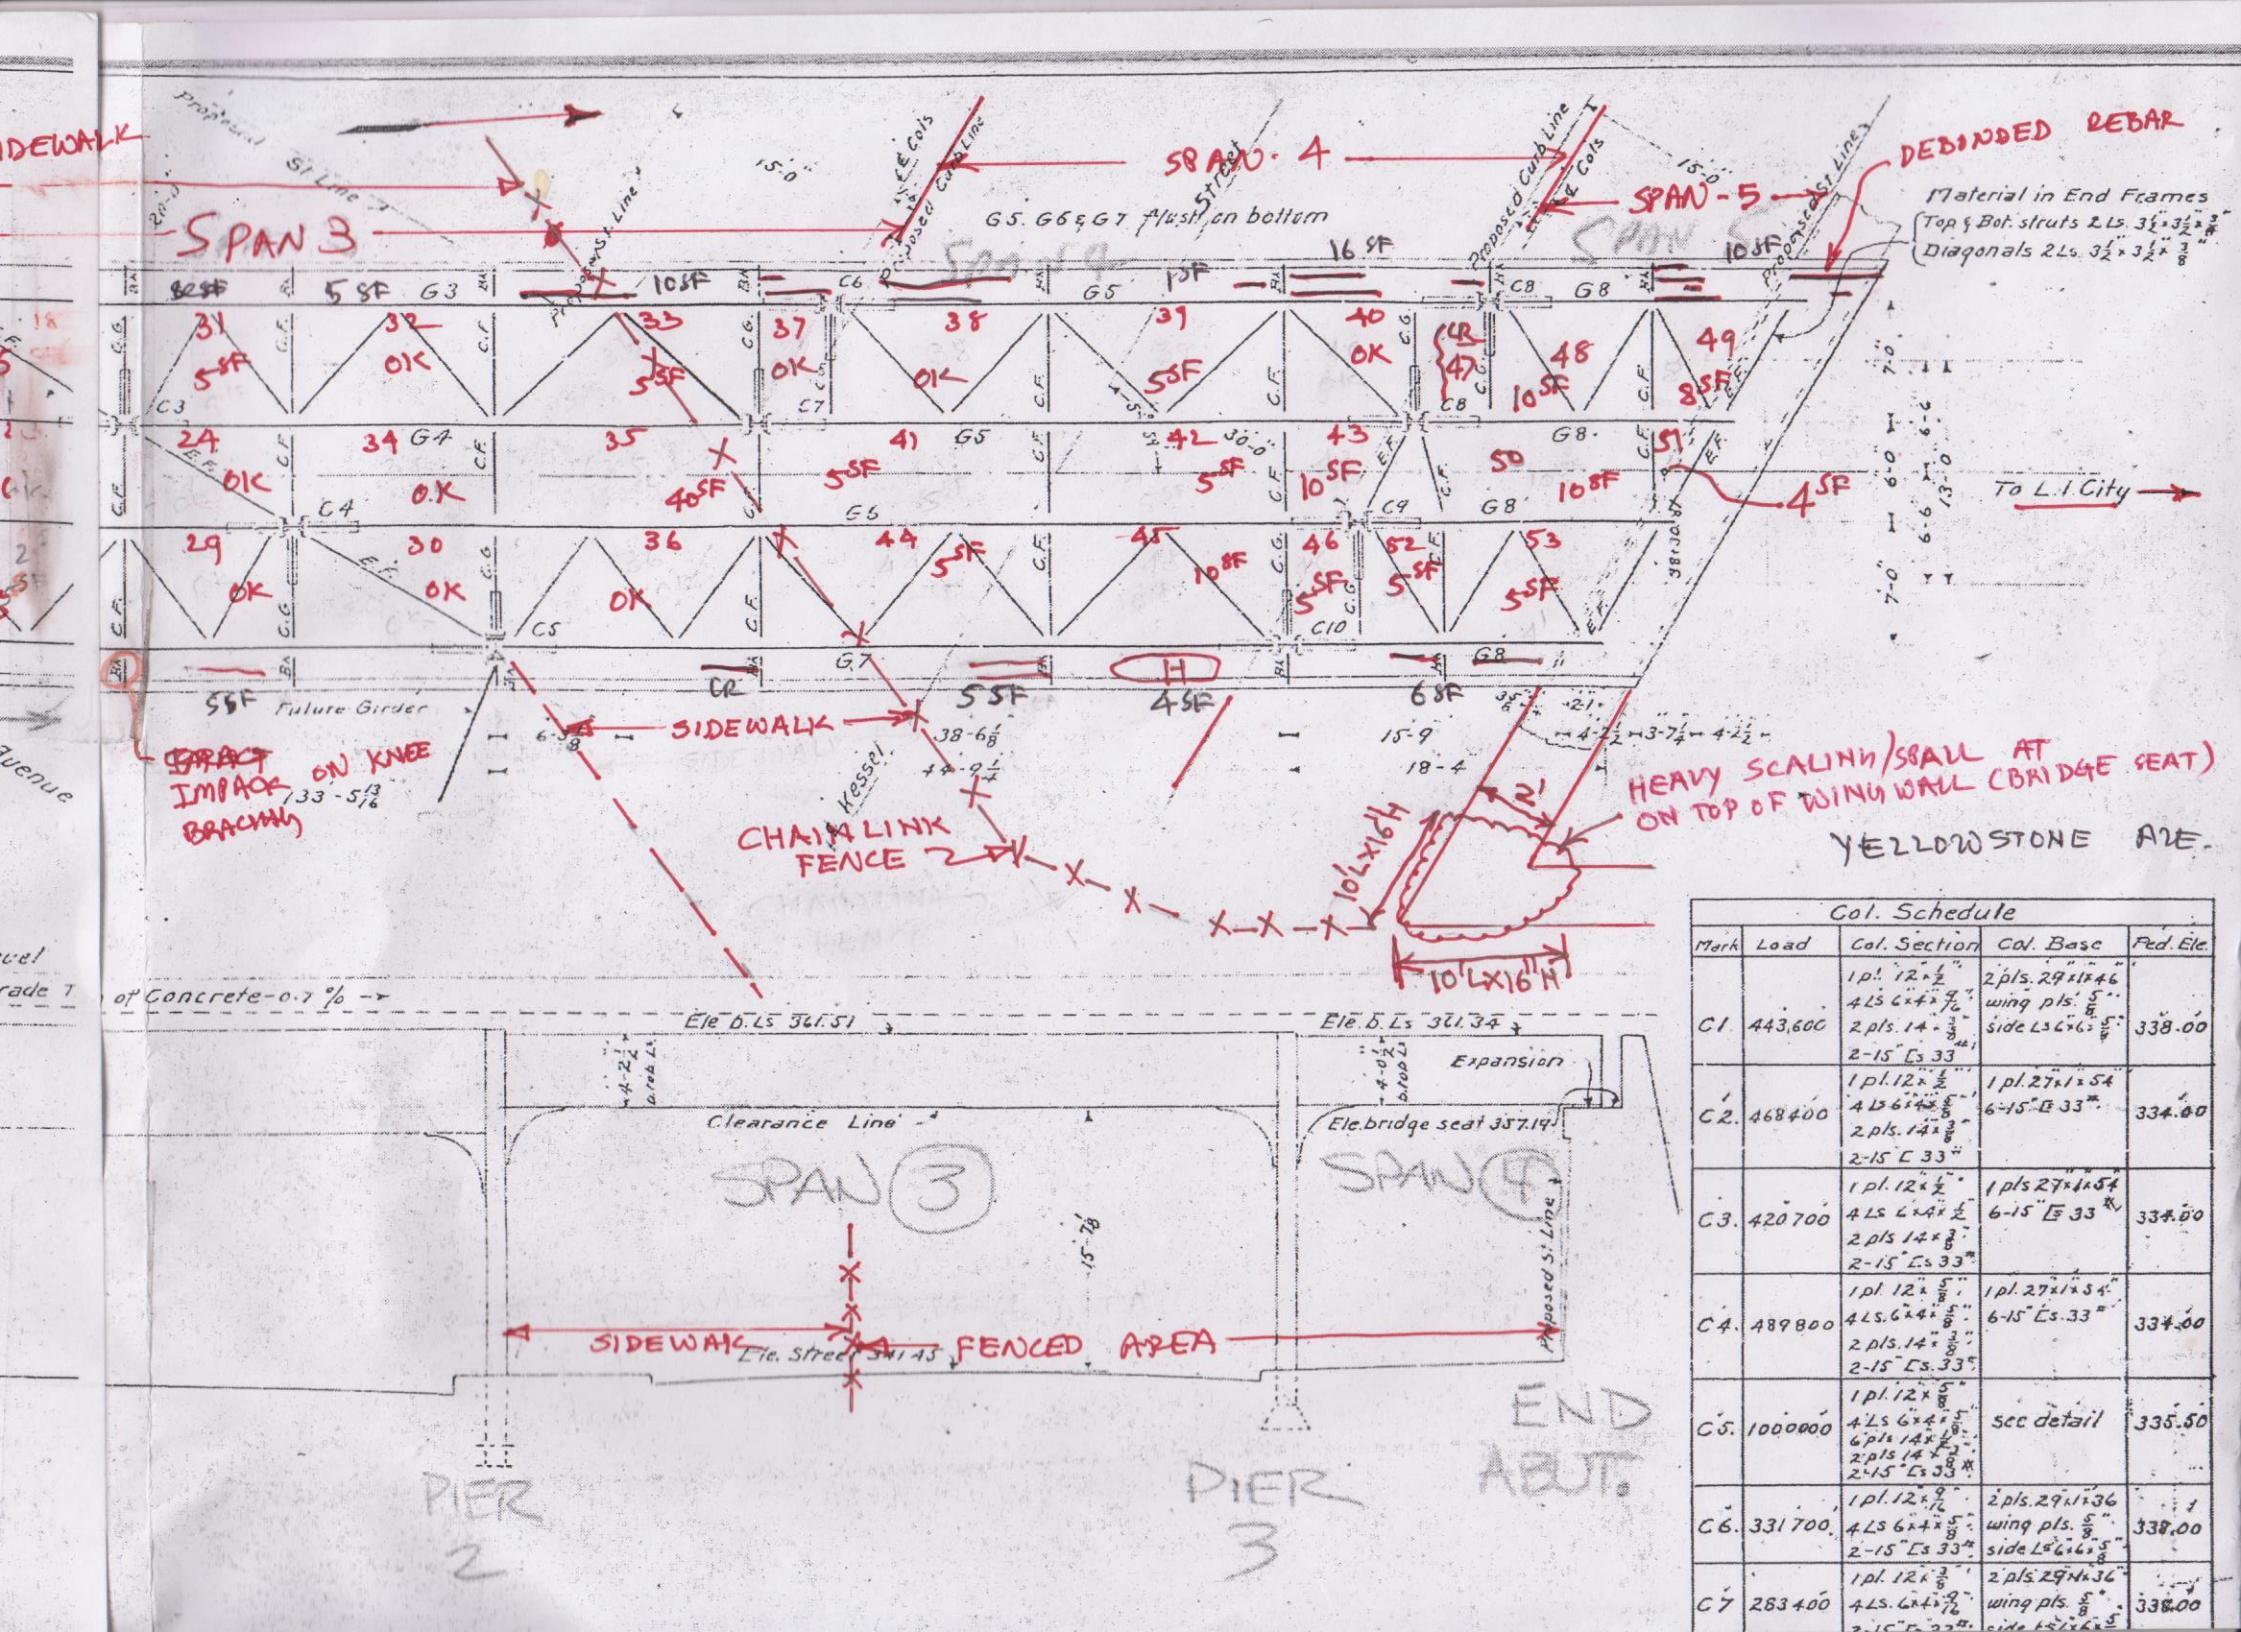
Yellowstone Boulevard Bridge

UNDE	LSIPE	Decle	YellowstonE
	BA	/ «»»:- )		BAY 2		BAY-3
SPAN-1	672	x5% =	87 2 5	576 x 51.	SF = 2 9	SF 1)x B x 5-1. = 4
	2 9×7	× 15% =	10 6	16×6× 30	y. : 30 11	D 11x7x \$%= \$
	3 16×	)× 20%.3	22 7	lix6x s	7. * 5	11 Ole
	4 11×	7× 5 7. :	35 8	CRACE	S'LX1/8"W	12 Ole
· 			34		37	7
	an and a start start and and a start start start start and a start and a start start start and	2005. 1970 -	(-90 SF	) -	11 - 110 - 111 - 111 - 111 - 111 - 111 - 111 - 111 - 111 - 111 - 111 - 111 - 111 - 111 - 111 - 111 - 111 - 111	
	BAY			BAY.2		BAN.3
SPAN.2	13 9x7x	BY 3	19	HEES OK		1577 x 57 = 6
	14 11x 23	A107 2	2-0	15- 6×54.	Z 26	15x7x201=3
	15 15×7>	157 6	21	1576x 5%	<u>\$ 27</u>	1577x 307.3

Yellow STONE GLUMNS BEG CH. BECHIN RUCICATURY Amgle (TYP.) de" CCH. 31/11 (TYP) , God WEB q11 NN × 3/167 26 11 WEB A To 321 END CITY 61713 61 #4 Co1+11. 61H2 4"x 2"14 Hule 4"xi"H Hole 4x3"HHd PI WEB 15% SL 35% SL. BEG CH. 20%. SL 157.5L 20% 50 %. SATION. SLAPPIN 2051.51 END UH 15%.SL 20% SPALL @ BAKE - 10-15% & O BAKE ANGLE 4×3H Hole P2 MEB Ole 104 OR de REG ON 20%. KL END CH 20%. SL IMACT ON 10-15-3. AL ANHLE Correct 61.2 (o). ! WEB A"XI'H Hole P.3 Ole REG CH 20%.  $\times$ Х END (4) 20%. 2..... 3 4 COL #1 P 4 WEB 257. X3"H WBB 25% SOV. SLO DOTH LEAS 751. SL 357.52 RECT CIT BOTH LEGS WEB 25% > DOTH LEG 100% x 4"H HOLEI 501. x2'H Eand CH. 4"HX 4W HOLE, I"H X10% & 1 10% For 1"H 1 15%. WEB Amgles 10-151.820 PANE SPALL OM SPall OM CONC. ENCA. ON LEFT SEND SIDE ENCAVEMET ALL FOR FULL ARON NO-MTarw

**Steel Substructure.** At Yellowstone Blvd., we recommend that all the column base concrete encasements be replaced, and the columns with section loss be reinforced. For all three bridges, and blast cleaning and painting of the steel substructure elements is recommended.

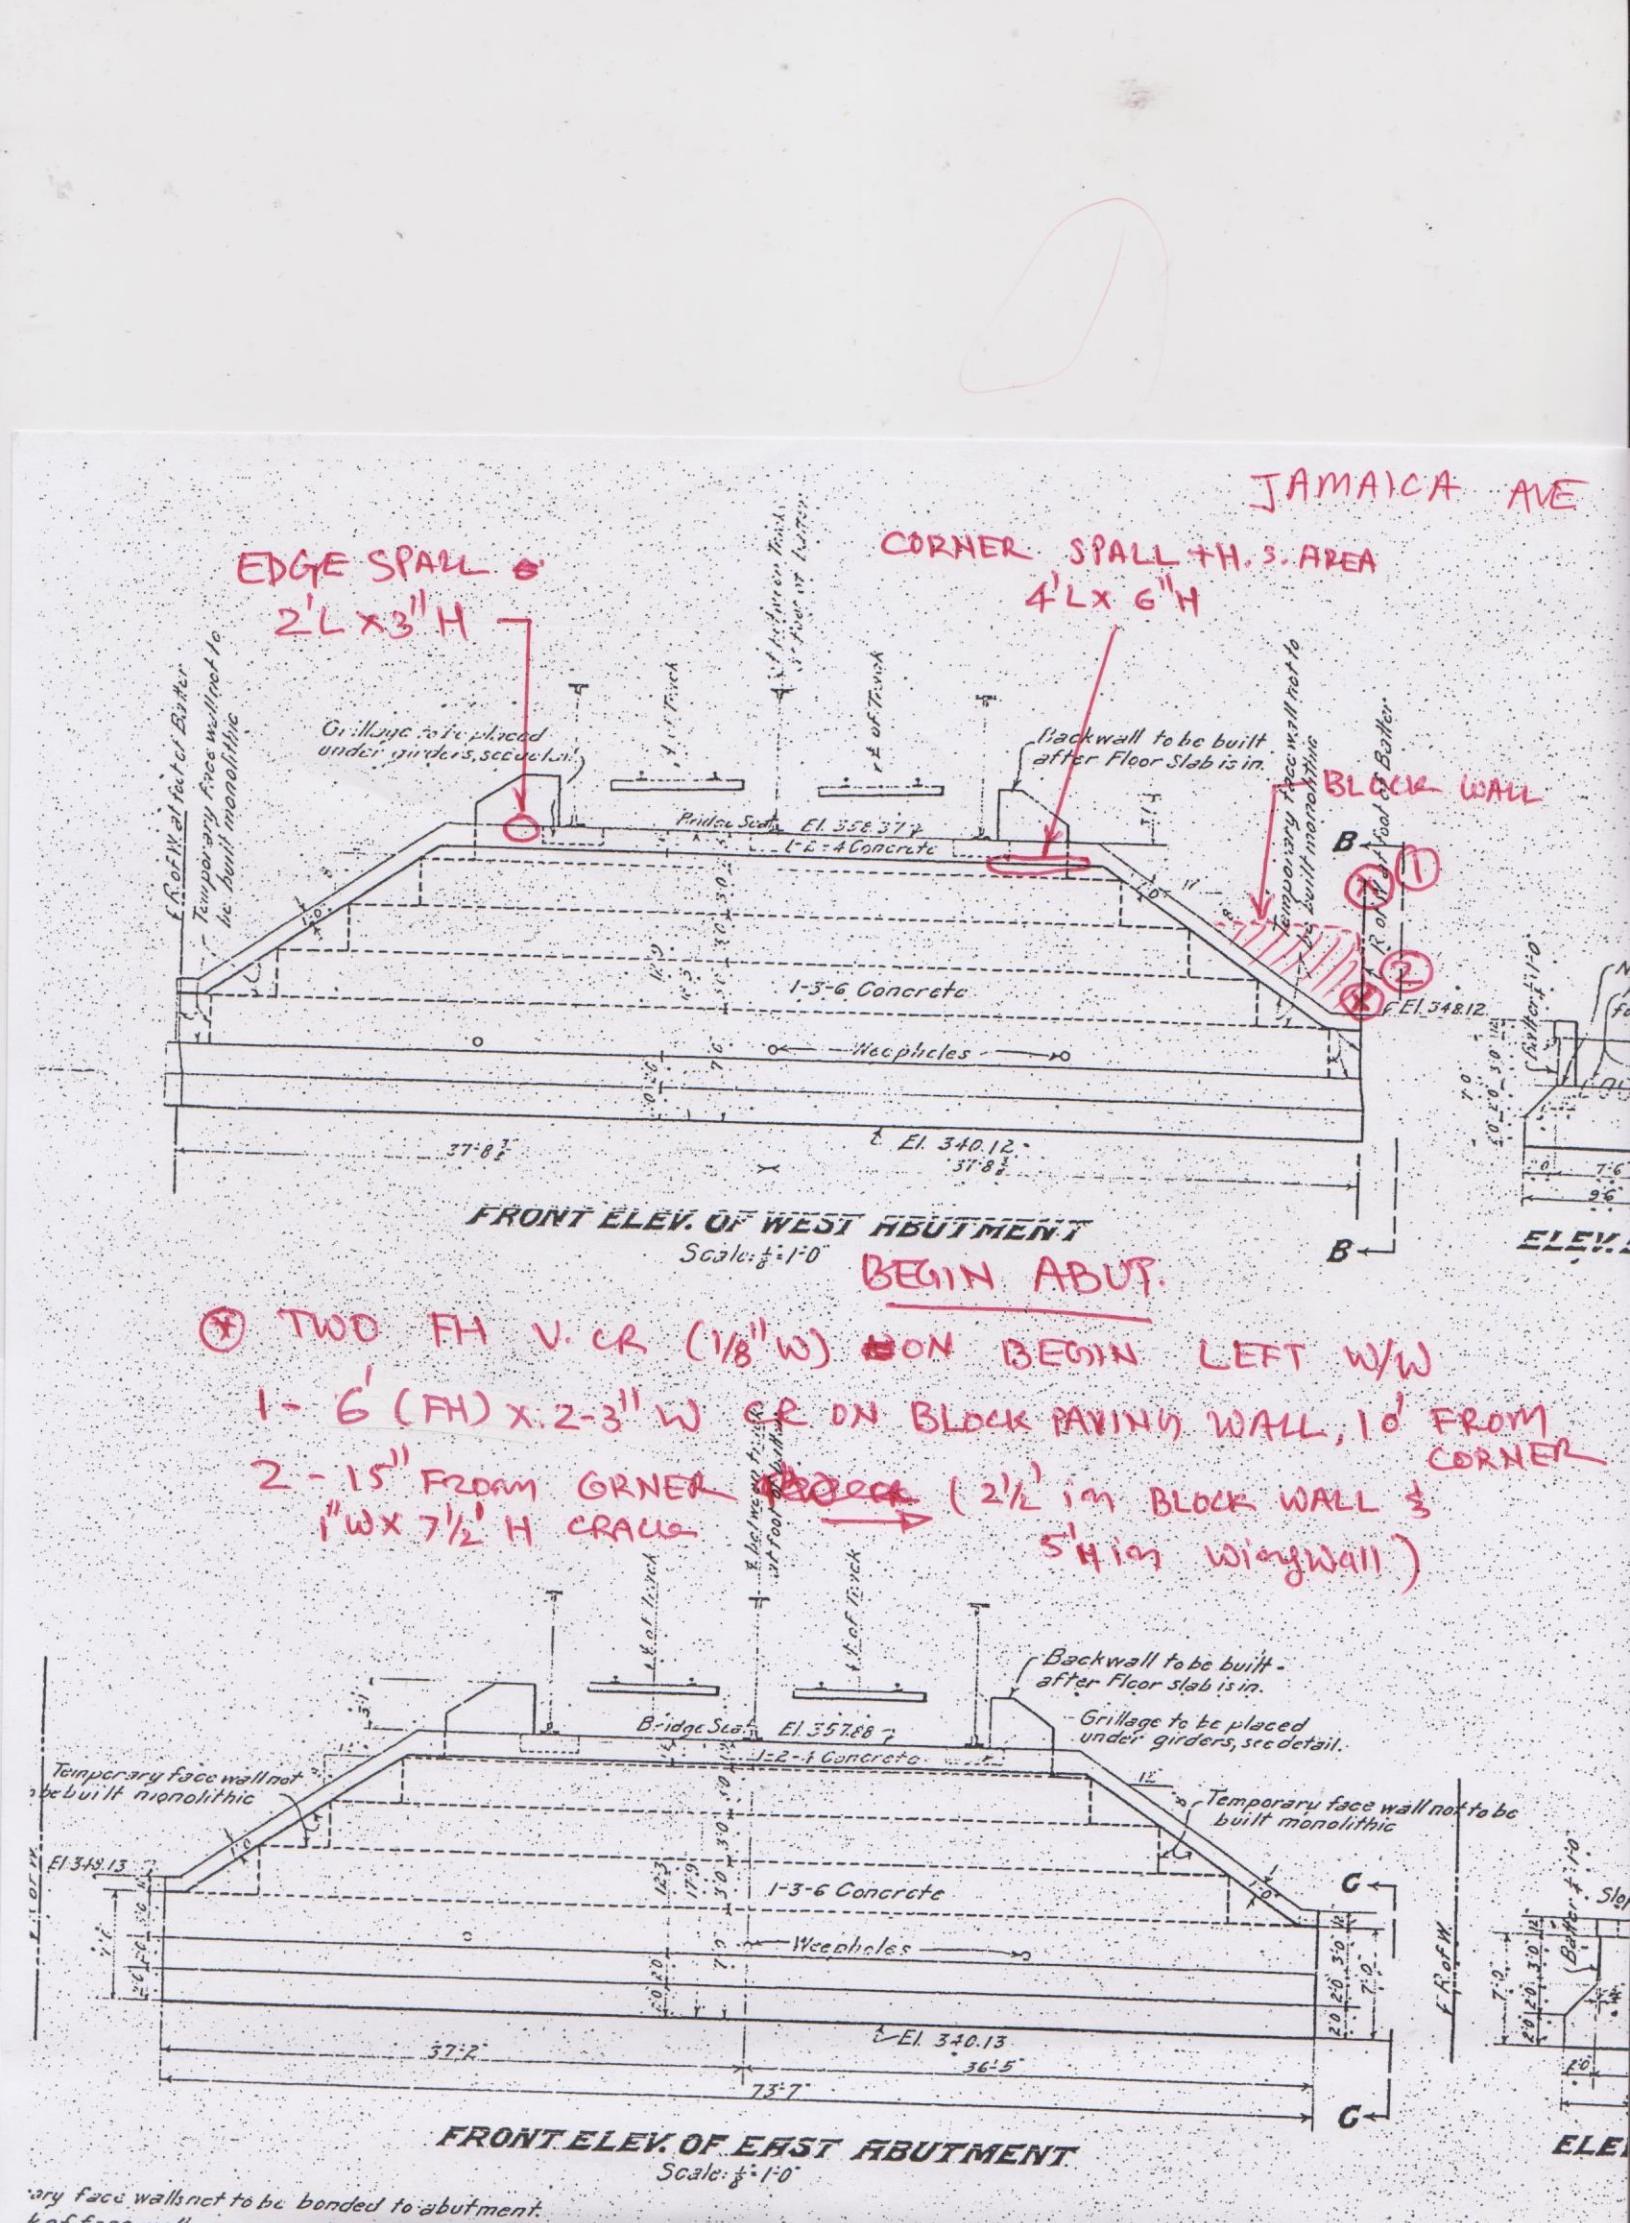
Jamaica Avenue Bridge

SPALL NOTED

FLAT SL	AB (	27)	٦			E	9				C	0			G	20	٩			3	)		¢	)t	
TO NEW YORK	17 68×51	e.				SPA	20 CED	× ABT	* 65 26	Is c.R	U.	584. 389. + 81.57		Sa: 06: 30	AND & CASTAGE	<b>U</b> .		أحد	21				10°	et states the	1365101
SHE RIGHT.	SEGRIDGE MY	. 4											EL. Sr. 344.10		9	4	<b>↓</b> 30"	1.01	<u> </u>			9		AL OFISI	120
JE ANOXIC

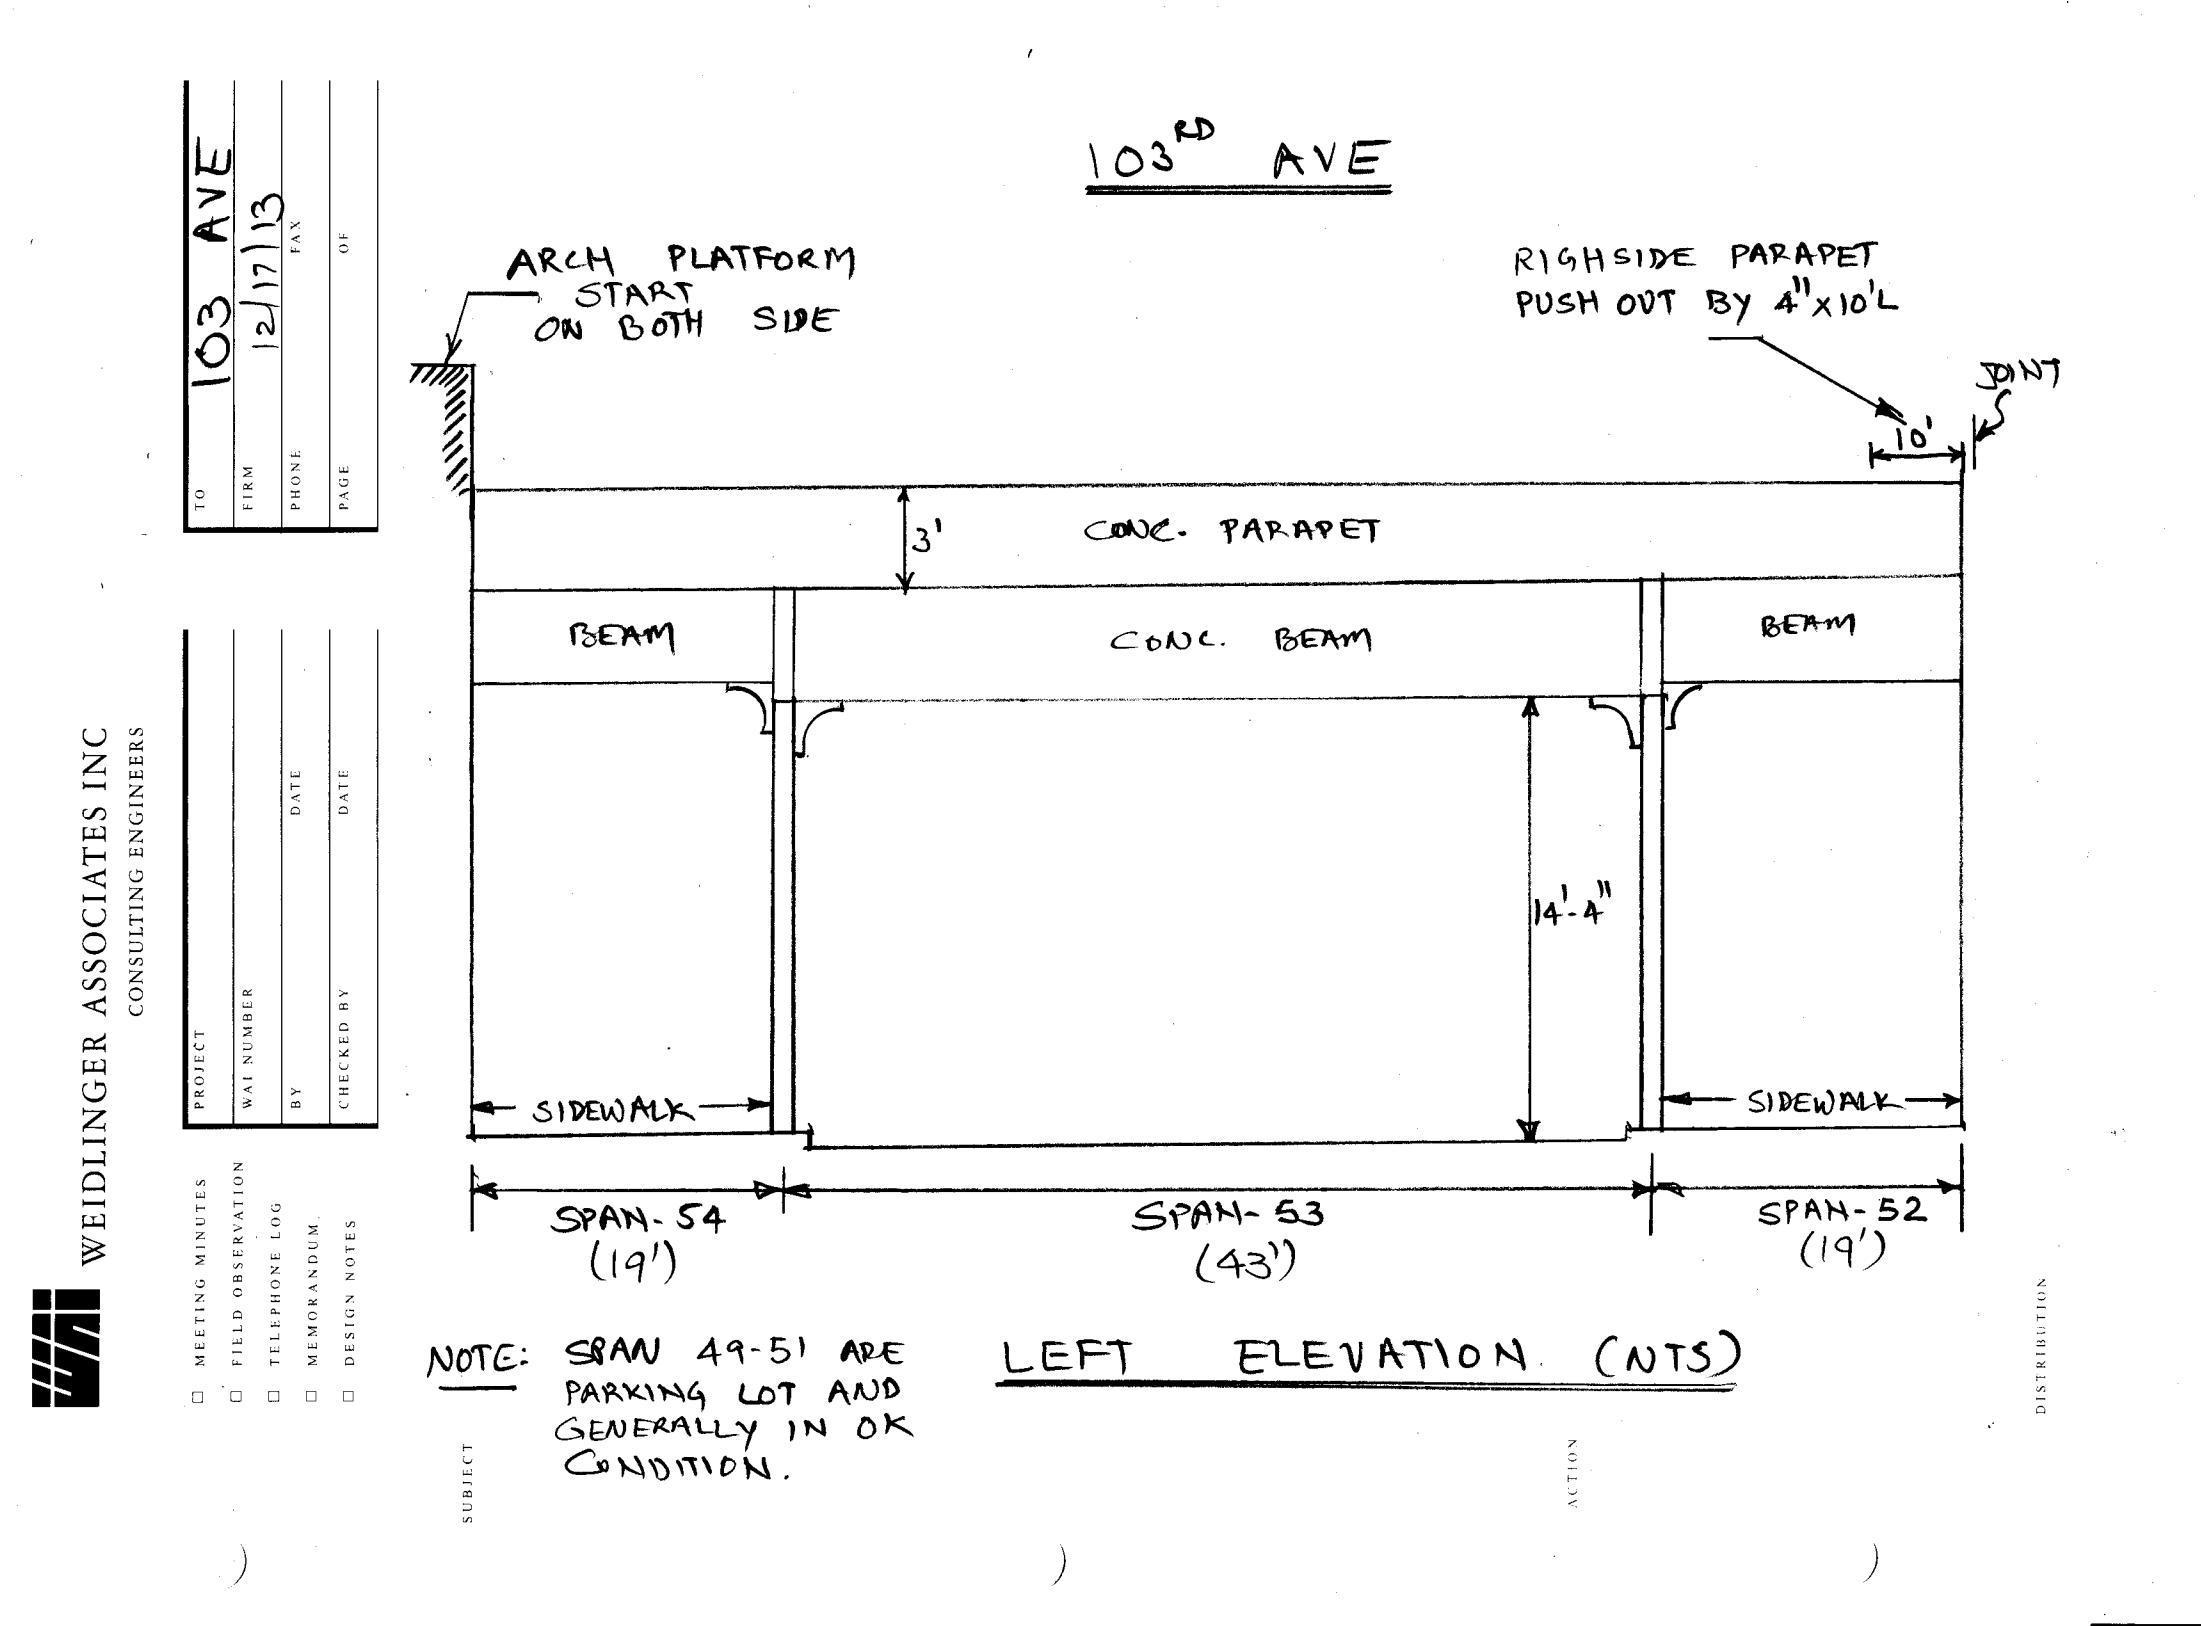
**Elevated Viaduct – 103 Avenue Bridge**

NOTE: DABOUT 10-15% DELAMINATED CONC. AREA NOTED N=>To L.I. UTY 117113 IN ALL THREE SPANS. AVE (2) SPALL ON VERTICAL FACE OF FB'S ( 0.2 TO 0.34 x 3/4 D) -SEVERL CR. W/EFFLO ABOUT SO ON EACH BPAN. 'xi 6 N **M** Ó +**菲**科 255 PHONE 2 FIRM PAGE õ  $\bigcirc$ PB 8<sup>5F</sup> 205F **∆**<sup>\$F</sup> 3 AI8SF ISF L>B Ø L- A 10<sup>25F</sup> 2.5F ISF 伆  $\Box$ WEIDLINGER ASSOCIATES INC CONSULTING ENGINEERS 3SF 5 2<sup>SF</sup> DATE DATE b 6 102SF 6-8" CIC WAI NUMBER ΒY CHECKED 8 000 4' (TYP.) 010 10'L155F 5XISF ASP OBSERVATION MINUTES SPAN-54 SPAN- 53 SPAN - 52 ELEPHONE LOG 19' M E M O R A N D U M NOTES 43' 19 COLUMN: 18"×18" MEETING 10'L PARAPET 30" O SEC A.A CONC PUST OVT BY 34" @ 8EC BB 4" . 🗆 LEGEND: " CR. W) EFFLO. 1 STEEL R 14"W - SLUPPER  $\infty$ SPALL W/EXP. REBAR PLAN FRAMING HIT EXP REBAR (4"W) (NTS)

Deck Underside at bridges crossing over 97 Ave., 101 Ave., 103 Ave., Liberty Ave., and Rockaway Blvd. We recommend that the underside of the concrete decks be thoroughly sounded and cleaned to remove any delaminated concrete pieces at these bridges. We also recommend that all exposed steel be sandblasted and painted, including exposed steel reinforcement.
